Contaminant Screening Study Libby Asbestos Site, Operable Unit 4 Libby, Montana

Draft Sampling and Analysis Plan Addendum
for J. Neils Park and State Highway 37

July 2003

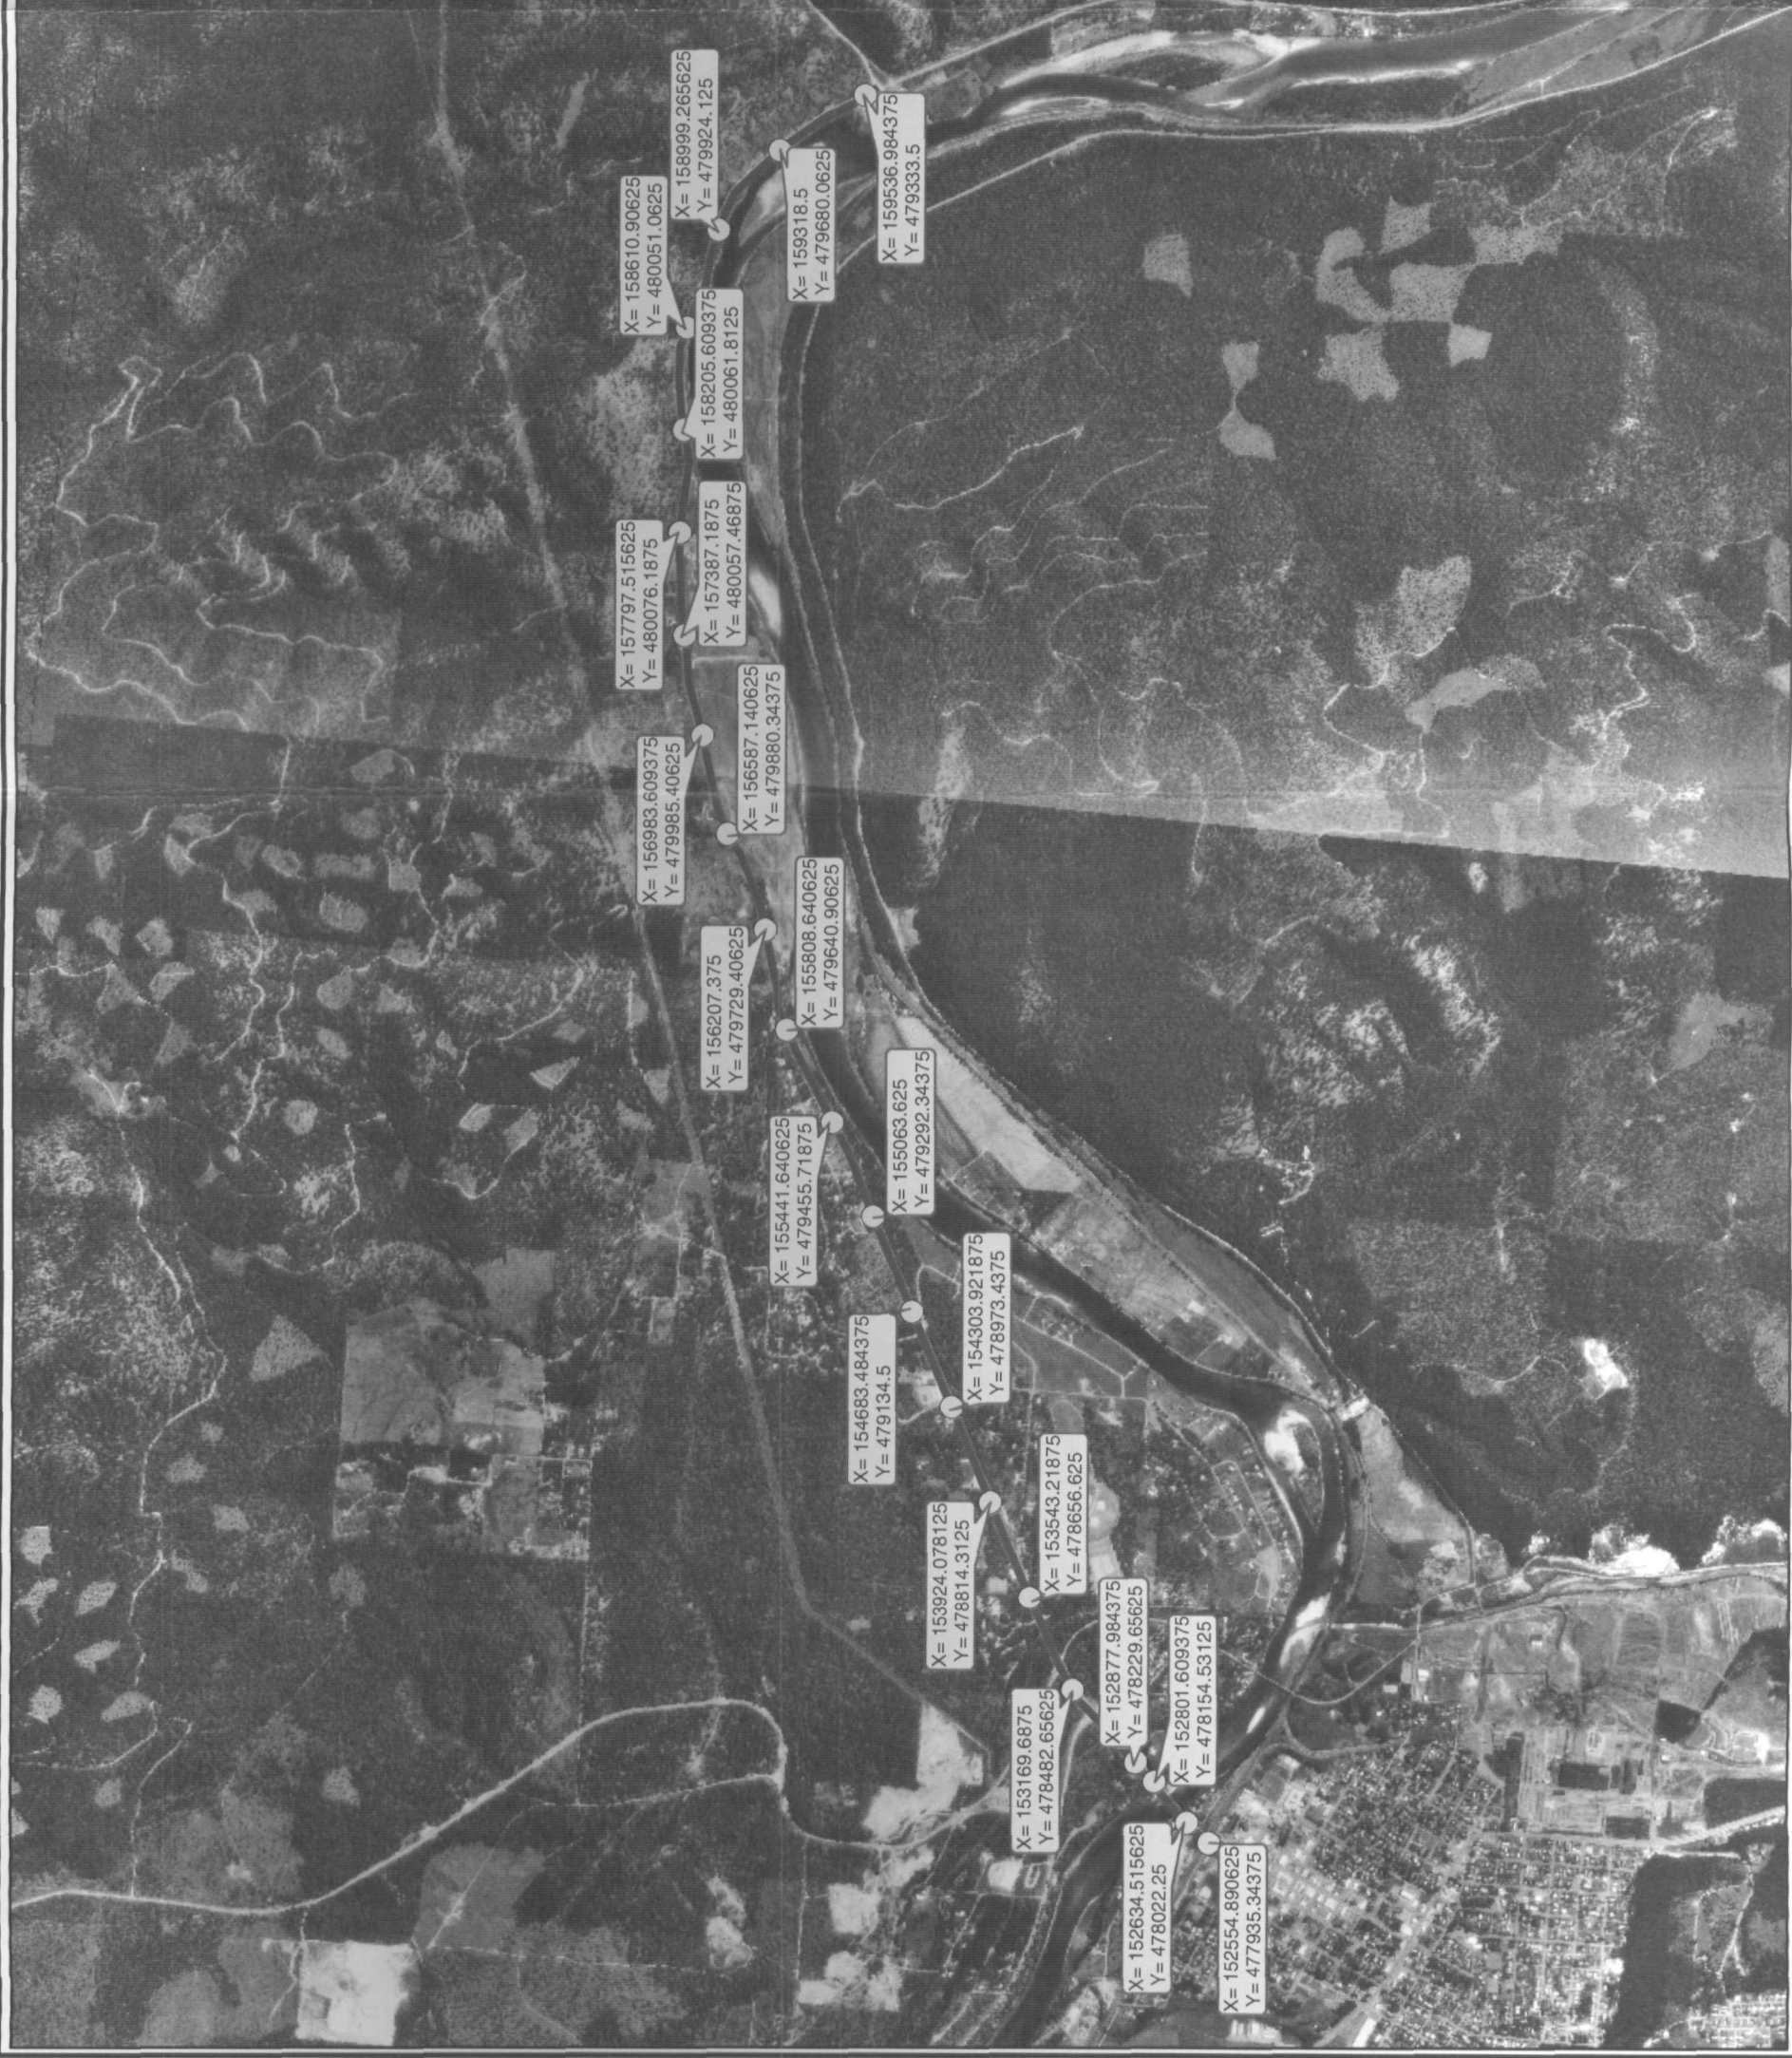
Figure 1-3
Sample Location Map
State Highway 37
Libby, Montana

CDM will coordinate with the Montana Department of Transportation to determine if permits are required to sample along the highway. The Highway Site was segmented into ¼-mile sections for sample location selection. The GPS coordinates in Figure 1-3 represent ¼-mile segments along the road with an additional two sample locations near the Kootenai River. At each of these ¼-mile intervals and the two locations near the river, one sample will be collected from each side of the highway. At each sample location (one on each side of the highway), three subsamples will be collected. Each of the subsamples will be collected from within 10 feet from the highway and no further than 20 feet from the highway (i.e., to stay within the highway right of way). These subsamples include the center location and one on each side parallel to the highway and approximately 100 feet from the center subsample location. If a smaller right of way is encountered, sampling teams will use professional judgment to determine appropriate subsample locations. These sample locations were chosen to provide a general idea of the nature and extent of contamination adjacent to the highway.

All highway site samples will consist of 3-pt composite samples. These composite samples will be collected from one center subsample location and two subsample locations parallel to the road and 100 feet apart.

Sample locations are mapped on each of the site figures (Figures 1-2 and 1-3), with the State Plane coordinates listed next to them. The following sections describe the sample locations and include the rationale for selecting these locations.

Surface soil samples will be collected from all designated sample locations. The locations of these samples are provided in Figures 1-2 and 1-3. Sampling is expected to last approximately 10 days.
